FLOATING BREAKWATER PROTOTYPE TEST PROGRAM: SEATTLE
WASHINGTON(U) COASTAL ENGINEERING RESEARCH CENTER
VICKSBURG MS E E NELSON ET AL. MAR 86 CERC-MP-86-3

FLOATING BREAKWATER PROTOTYPE TEST PROGRAM: SEATTLE, WASHINGTON

March 1986

Final Report

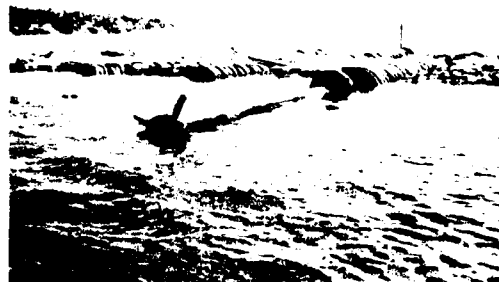
For nearly a year, the pipe-tire breakwater proved to be remarkably durable. Except for minor repairs to the keeper pipes, it withstood the winter storms of 1982 without any maintenance (photograph 23). But in June 1983, almost a year to the day after the pipe-tire breakwater was installed, the first problem of any consequence developed. After a minor storm, routine inspection revealed that one of the longitudinal pipes had broken (photograph 24). A closer inspection revealed that the 45-ft pipe had been fabricated from a 40-ft section and a 5-ft section. A poor weld between the two sections had finally failed because of a combination of corrosion and fatigue, allowing the two pipe sections to pull out of the tires. One month later, when a second pipe failed in exactly the same manner, a decision was made to terminate testing of the pipe-tire breakwater. During the removal process, the anchor lines were inspected, and no major problems were found in the nylon anchor lines or connecting hardware. After the breakwater was removed, it was surplused and eventually reinstalled at a private marina in southern Puget Sound. Monitoring of the long-term durability of this unit is planned.

Photo 24. A broken longitudinal pipe pulling out of the tires.

g. The keeper pipes on the pipe-tire breakwater should be redesigned. If a single 4-in.-diam by 40-in.-long keeper pipe were welded in place, the expensive 4-way cross coupler and 2-in. ID pipes which were vulnerable to corrosion and loosening could be eliminated. Also, designers should consider the potential for corrosion of all small metal parts such as cotter keys.

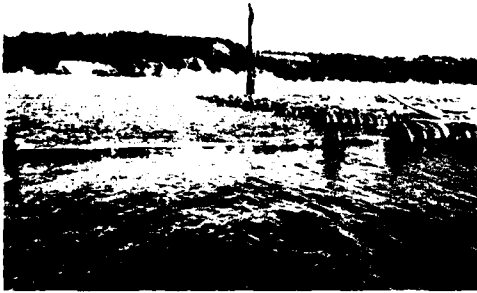
Photo B-31. A 45-ft pipe pulling out after breaking at a welded joint.

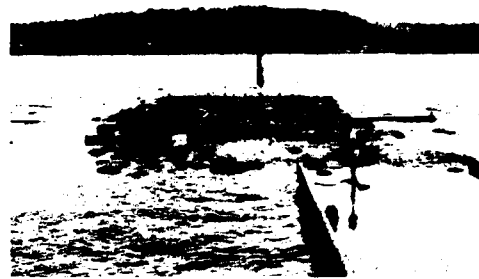
Photo B-32. The center pipe protruding from the breakwater after failure of keeper pipes.

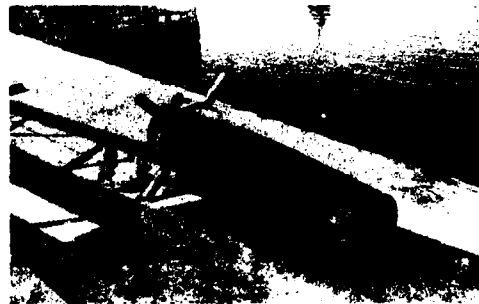
Photo B-34. Photo showing a clearly broken 5-ft section of pipe indicating an incomplete weld.

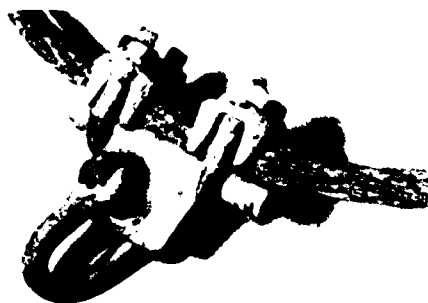
breakwater anchor line hardware did not appear to be significant; however, the galvanizing was completely gone from the steel bridge rope, and all the individual strands of the bridge rope that were examined were noticeably rusted (photo C-21). Several strands in the vicinity of the clump weight attachment clamp had broken. Some algae attached to the upper chains of the concrete breakwater anchor lines. Virtually no marine growth took hold on the galvanized anchor lines, but mussels, tunicates, and anemones had begun to attach to the clump weights by the time these weights were removed in October 1983 (photo C-22).

Photo C-21. Photo depicting clump weight attachment hardware (note corroded steel bridge rope anchor line).
